CFRP Repair of Corrosion-Damaged Bond Region

Ahmad A. Rteil

Khaled A. Soudki & Timothy H. Topper

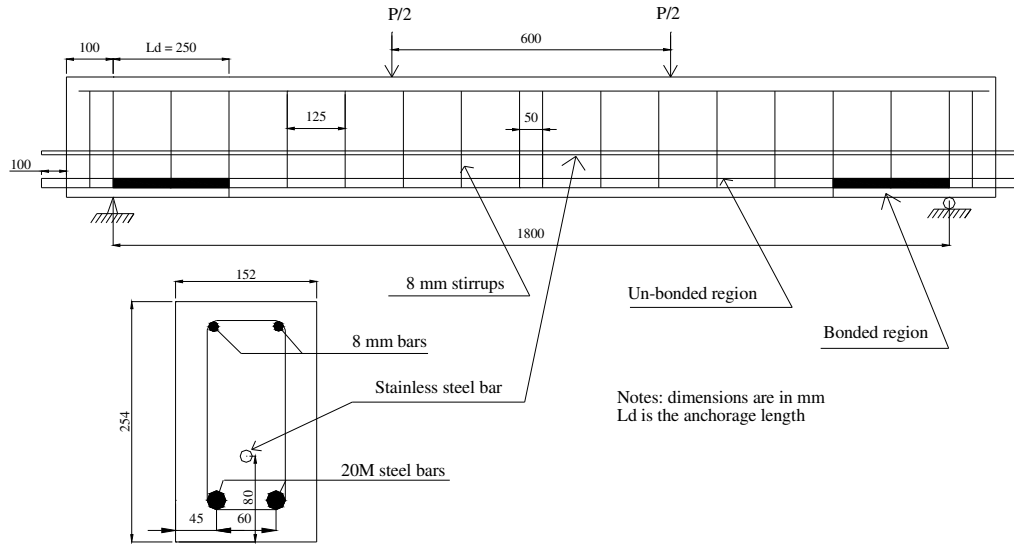
Figure 1. Anchorage-beam specimen details

Anchorage-beam specimens were used in this study in order to get realistic bond stress behavior (bond stress values and distribution). In an anchorage-beam, the tension steel bars are unbonded in the middle of the beam, thus limiting the force transfer between the steel and concrete to the bonded length (anchorage length) which was chosen so that the specimen fails by bond splitting before the steel yields. The specimens were 2000 mm long and had a rectangular cross-section (150 x 250 mm). Each specimen was reinforced in tension with two deformed steel bars, 20 mm in diameter, and in shear with 8 mm smooth hoop stirrups spaced at 125 mm (Fig. 1). The anchorage length was 250 mm. The unbounded length was created by covering the steel bars with low-density polyethylene (LDP) tubes. In addition, two pockets were created at the end of the bonded region to allow for easy instrumentation of the steel bars (Fig. 1).

The repair scheme consisted of wrapping the anchorage zone (at both ends of the beam) with a single U-shaped carbon fiber reinforced polymer (CFRP) sheet. The fibers orientation was perpendicular to the longitudinal steel in order to provide the required confinement for concrete against corrosion and bond stresses. The CFRP sheets were applied in accordance with the manufacturer procedure. It should be noted that the corrosion cracks were sealed by an epoxy before the beams were wrapped.

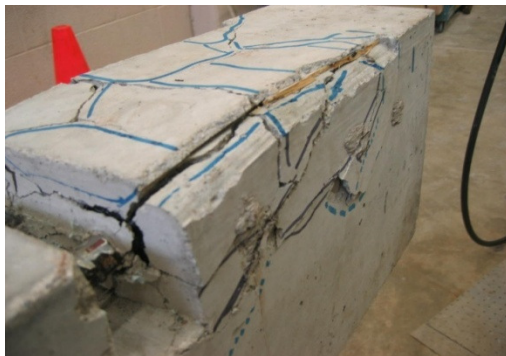
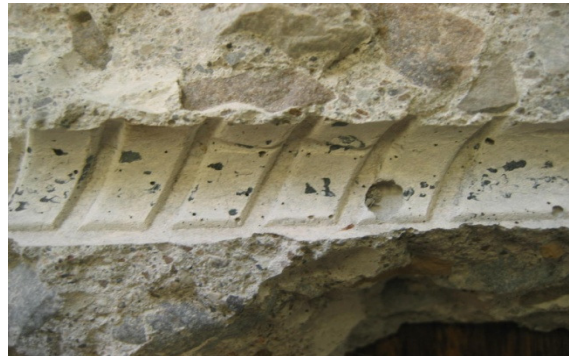
Figure 2. Failure of the uncorroded unwrapped beams (group UW0).

In the unwrapped uncorroded beams (group UW0), longitudinal cracks initiated at the pocket and ran along the reinforcing bars during the first few cycles. As the number of cycles increased, the number and width of these cracks increased. This behavior took place at both ends of the beams (where the bonded zones are) and continued until about 20% to 25% of the beams' life after which the cracks ceased to grow. At about 80% to 90% of the beams' life the longitudinal cracks in the bonded area started to widen again at one end of the beam and continued to widen at an ever increasing rate until failure. The failure of all the unwrapped beams was by bond splitting (Table 1) of the concrete cover at the side and bottom faces of the beams (Fig. 2a). After the tests were stopped the failure plane of the concrete was examined. It was noticed that the concrete keys (concrete between the steel lugs) in the bottom concrete cover were intact (Fig. 2b) while the concrete layer above the steel bar in the vicinity of the steel lugs was crushed. This implies that the bond forces pushed the bottom concrete cover away by wedge action and only the upper concrete layer above the bars that was held against the bars by the stirrups provided resistance to the bond forces.

a) Concrete splitting

b) Failure plane for unwrapped beams (bottom cover)

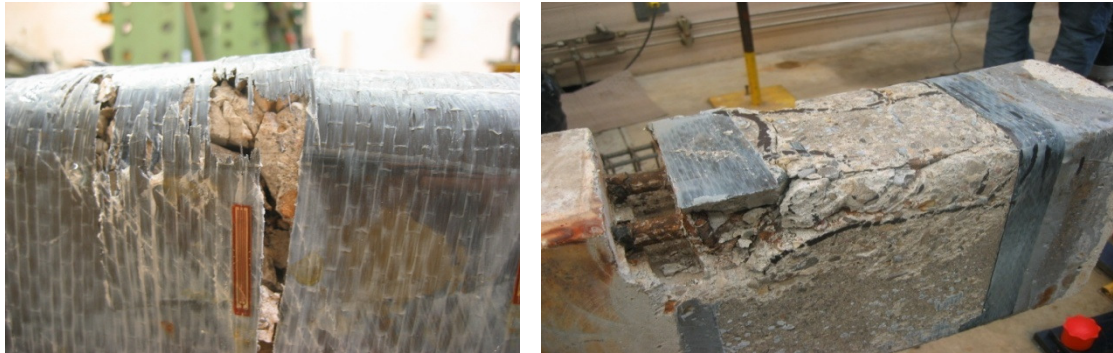
a) CFRP failure
b) Splitting concrete cracks
Figure 3. Bond failure of the wrapped corroded beams (Groups W5 and W9).

The corroded beams had longitudinal cracks due to corrosion before the beams were tested. These cracks were sealed with an epoxy before the CFRP wrapping was applied. During the testing of these beams, the presence of the CFRP sheets prevented a visual inspection of the crack behavior. It was realized that the majority of the beams failed when the CFRP sheets ruptured at both sides of one of the beams' anchorage areas while it remained intact at the other end (Fig. 3). After the tests were halted, the CFRP sheets were removed and the concrete surface was inspected. The concrete surface of these beams had longitudinal splitting cracks signifying a bond failure (Fig. 3). Also in these beams both the concrete cover and the layer above the steel showed evidence of crushing indicating that the confinement provided by the CFRP sheets resulted in forcing the concrete to remain in contact with the steel. The concrete surface at the other end had little or no longitudinal cracks. A few of the beams (Table 1) failed when the steel bars ruptured before concrete splitting. This is due to the lack of corrosion protection for the steel at the pocket, which resulted in severe corrosion pits that initiated the fatigue failures. It should be noted that beams failing in steel rupture are excluded from the following discussion.

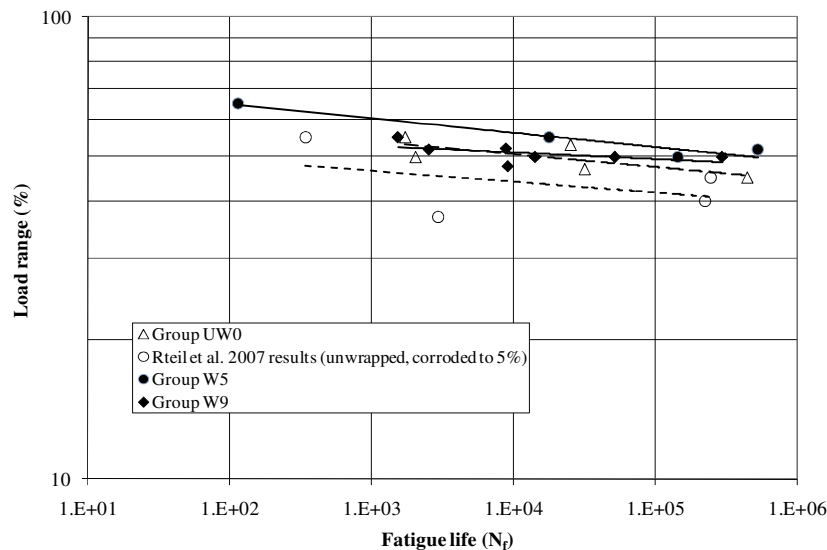
Figure 4. Variation of the load range with life.

The fatigue lives of the specimens reported in this paper are presented in Table 1 and shown in Figure 4. Also shown in Figure 4 are previously reported results of tests on unwrapped beams corroded to a 5% mass loss (Rteil et al. 2007). As the applied load range increases, the bond fatigue life of the specimens decreases linearly on a log-log scale (Fig. 4). The fatigue strength of Group W5 (wrapped and corroded to 5%) increased by 26% compared to their unwrapped coun-

terparts (unwrapped and corroded to a 5% mass loss). The fatigue strength of the wrapped specimens corroded to a 5% and a 9% mass loss increased on average by 11% and 4% respectively compared to that of the unwrapped uncorroded specimens. Comparing groups W5 and W9 it is shown that increasing the corrosion rate from 5% to 9% decreased the fatigue life of the specimens by about 6%. The CFRP sheets increased the fatigue strength of the corroded specimens at a low corrosion rate to a level above that of the uncorroded unwrapped specimens. Even at the higher corrosion rate the strength was restored to its original level.

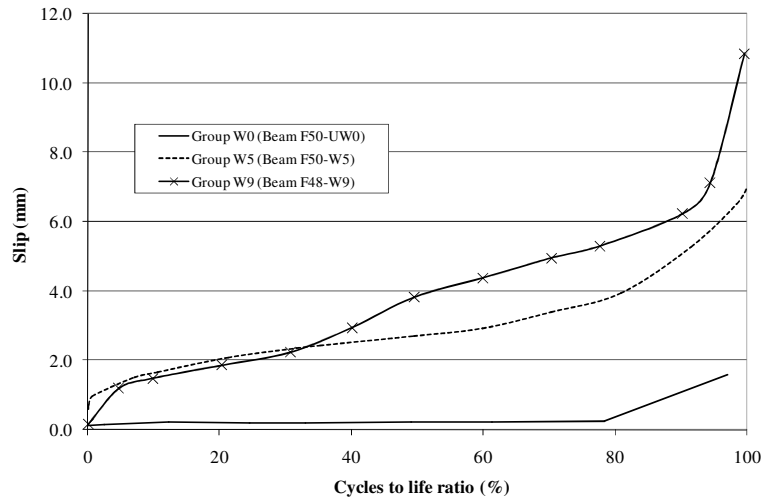
Figure 5. Typical slip behavior of the wrapped and unwrapped beams.

The slip of the uncorroded unwrapped beams (Group UW0) shown in Figure 5 can be divided into two parts. In the first part the slip does not increase much, however, in the second part, the slip increases exponentially. The duration of the first part depended on the load range applied. As the load range increased the duration of the first part decreased from 90% of the beams' life to 30% of the beams' life.

For the corroded wrapped beams, the slip behavior was different. In the first 5 to 10% of the wrapped beams' life, the slip increased rapidly to about 1.5 to 2.0 mm (Fig. 5). After that, the slip continued to increase but at a much slower rate. The rate of slip increase for both corrosion levels (5% and 9% mass loss) was 0.033 mm per 1% of the cycle to life ratio. Between about 90% of the cycles to failure and failure the slip increased exponentially (Fig. 5). It is interesting to note that a similar behavior was also recorded for the variation of the CFRP strain. The strain in the CFRP sheets increased rapidly during the first 4 to 8% of the beams' life. After that, the
