## First Use of GFRP Bars as Reinforcement for Continuous Reinforced Concrete Pavement

B. Benmokrane<sup>1</sup>, M. Eisa<sup>1</sup>, S. El-Gamal<sup>1</sup>, E. El-Salakawy<sup>2</sup>, and D. Thebeau<sup>3</sup>

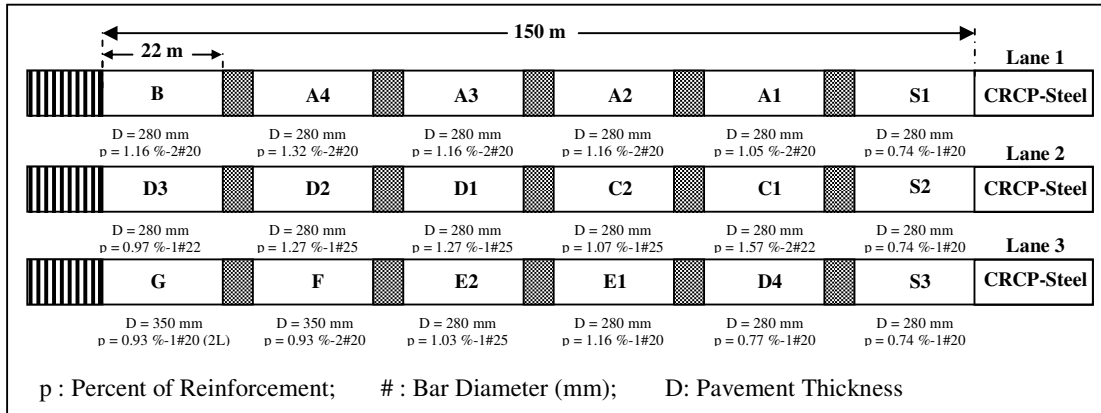
Figure 1. Layout and basic design parameters of test sections

Highway 40 East consists of 3 lanes, 3.7 m each. The test slabs represent a 150 m long section of the highway with the full width. Fifteen (15) slab portions of the three-lane were reinforced with GFRP bars. In addition to these 15 slab portions, 3 additional slab portions were constructed and reinforced using galvanized steel bars for comparison purposes. The width of 11.1 m constitutes the adjacent three lanes of the highway (3 lanes  $\times$  3.7 m in width). Each slab portion has the dimensions of 25 m long and 3.7 m wide. Six slab portions were implemented per each lane (see Figure 1). The representative length of 25 m was carefully chosen along which reliable conclusion could be drawn on the behavior of the entire test area. In-between distances of 3 m in the longitudinal direction were used as transition zones to over-lap the GFRP reinforcement of the adjacent portions. The area of the project constitutes the far-end of a 9-km part of Highway 40 East in Montreal constructed (May-September 2006) using the CRCP system reinforced with galvanized steel. Details about section layout and basic design parameters are presented in Figure (1) and can be further reviewed in Eisa et al. (2007).

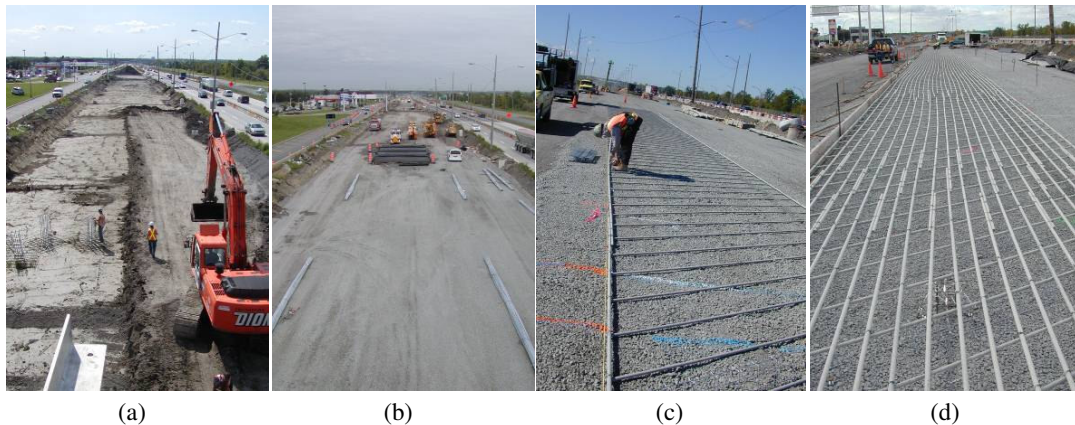
Figure 2. Construction of the test project

The construction work of the test project started in August 2006 with the CRCP foundation (Figure 2a,b), which was composed of three layers: base, subbase, and subgrade soil. In this project, 150-mm of open graded drainage layer (OGDL) and 450-mm of MG-112 were used for the subbase while 150-mm of MG-20 was used for the base. GFRP reinforcing bars No. 6, 7 and 8, manufactured by a Canadian company (Pultrall, 2006) were used for the longitudinal and transverse reinforcement of fifteen slab portions (pavement). Table 1 shows the mechanical properties of the used GFRP bars. The reinforcement placement started with the center lane (No.2) by placing the horizontal reinforcement bars crosswise at a 30° angle to the transverse line and spaced 500 mm center-to-center (Figure 2c). Afterwards, longitudinal bars were placed according to the designed plan. The splicing of the longitudinal bars was done according to another work done by Kohler et al. (2002), and consisted of three separate plans over a 3 m width (1/3 of bars spliced per plan) as shown in Figure 2d.

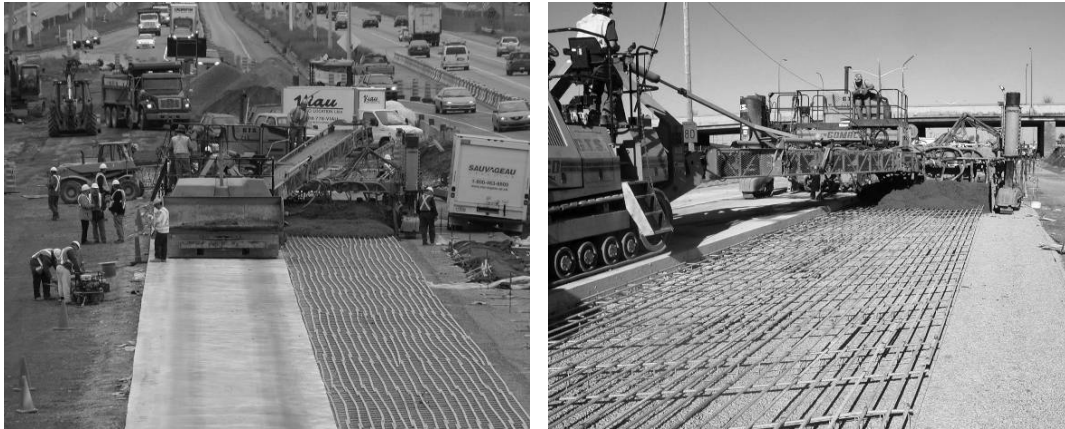
Figure 3. Concrete casting

The contractor had a mixing plant set up near the job, and the concrete arrived at the project in flatbed trucks. A paving train with a slipform paver features a GOMACO-GT6300 operating at a width 3.7-m was used to cast the concrete as shown in Figure 3. The first day of concrete placement was September 26, 2006, starting with the center lane. Later, the concrete placement was done for the left lane and the right lane in October 2<sup>nd</sup> and 6<sup>th</sup>, respectively. The concrete production was varied between 60 to 90 m<sup>3</sup> per hour for the mainline paving casting a total quantity of 564 m<sup>3</sup> for the three lanes in this project. The highway 40 including the demonstration sections was opened to traffic at the end of October 2006.

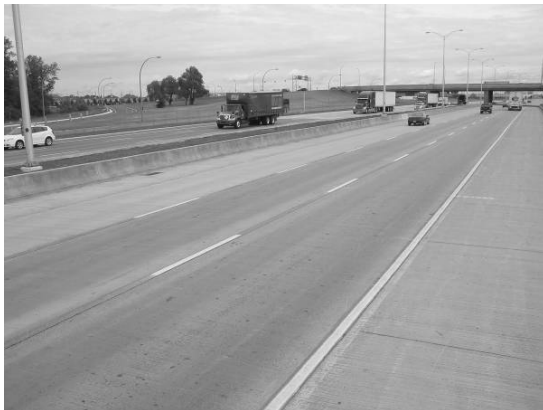
Figure 5. Overall view for Highway-40 (taken in June 2007)

About one year is the age of the GFRP-CRCP slabs at the time of writing this article. Up till now, the preliminary overall view of all slabs is satisfactory as shown in Figure 5. No major distress has been observed such as: pumping, faulting, spalling and punch-out failure in the surface of the CRCP slabs.

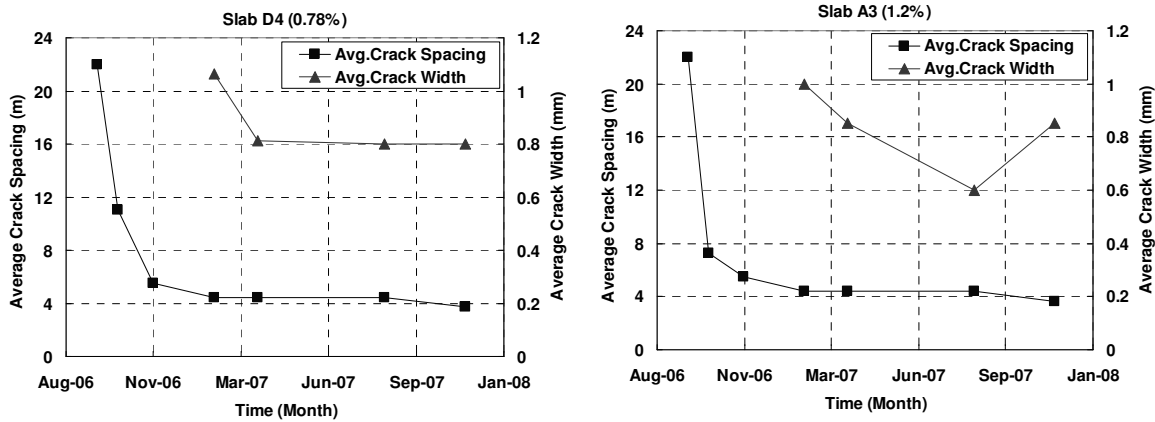
Figure 6. Average crack spacing and average crack width for selected CRCP slabs

Crack spacing and crack width are acknowledged as the most critical factors which control the performance of CRCP slabs. The acceptable limits of these factors can ensure satisfactory performance of CRCP under the anticipated environmental and vehicular loading conditions. In this study, tracking of crack propagation and crack width started from the first day of construction using mapping wheel and crack comparator, respectively. Figure 6 shows the average crack spacing and crack width for selected CRCP slabs during the first year after construction. The results show that the average crack spacing varies from 3.0 to 5.0 m in most GFRP-CRCP slabs. In addition, the average crack width in the GFRP-CRCP slabs varies from 0.75 to 0.9 mm which is relatively matching the average crack width values (0.9 mm) recoded for steel-CRCP slabs and within the AASHTO design limits.
