STRENGTHENING OF MASONRY WITH NEAR SURFACE MOUNTED FRP BARS

J. Gustavo Tumialan, University of Missouri-Rolla, Rolla, MO

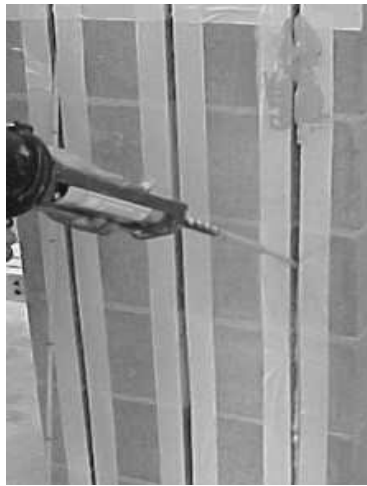
(a) Application of Embedding Paste

Figure 1. Installation of NSM FRP Bars

The NSM technique consists of the installation of FRP reinforcing bars in slots grooved in the masonry surface. An advantageous aspect of this method is that it does not require sandblasting and puttying. The strengthening procedure can be summarized as: (1) grooving of slots having a width of approximately one and a half times the bar diameter and cleaning of surface, (2) application of embedding paste (epoxy-based or cementitious-based) (see Figure 1a), (3) encapsulation of the bars in the groove (see Figure 1b), and (4) finishing. If hollow masonry units are the base material, special care must be taken to avoid a groove depth exceeding the thickness of the masonry unit shell, and local fracture of the masonry. In addition, if an epoxy-based paste is used, strips of masking tape or other similar adhesive tape can be attached at each edge of the groove to avoid staining of the masonry (see Figure 1).

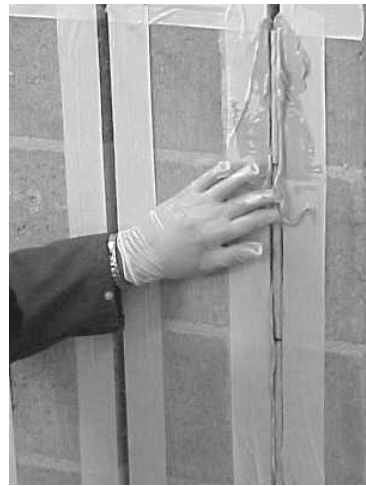
(b) Encapsulation of FRP Bar

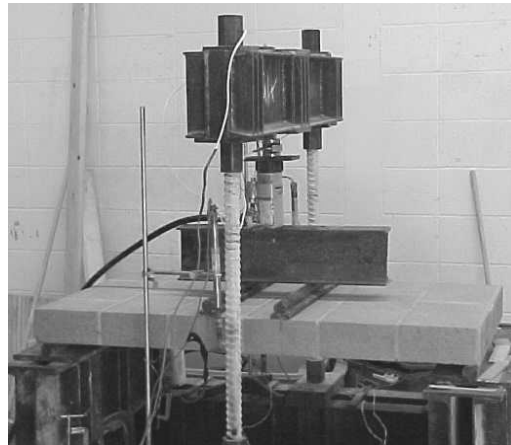
Figure 2. Test Setup

The walls were tested under simply supported conditions (see Figure 2). An out-of-plane load was applied along two load lines spaced 8 in. Linear Variable Differential Transducers (LVDTs) were placed at midspan and supports to register deflections and settlements. Also, strain gauges were placed on the GFRP bars to record strains at different levels of load.

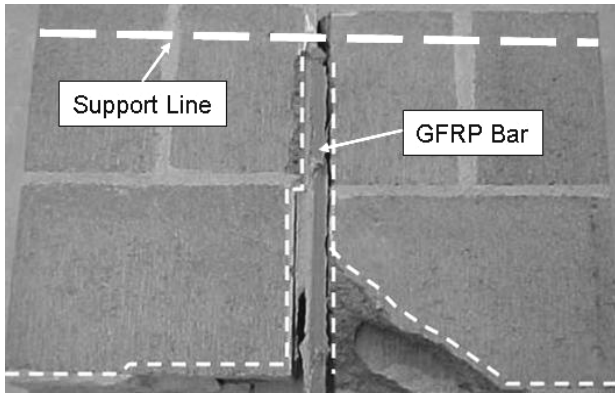
Wall 1 failed due to debonding of the embedding material from the masonry. Initial flexural cracks were primarily located at the mortar joints. A cracking noise during the test revealed a progressive cracking of the embedding paste. Since the tensile stresses at the mortar joints were being taken by the FRP reinforcement, a redistribution of stresses occurred. As a consequence, cracks developed in the masonry units oriented at 45° (see Figure 3a) or in the head mortar joints. Some of these cracks followed the epoxy paste and masonry interface causing debonding and subsequent wall failure.

(a) Debonding Failure (Wall 1)

Figure 3. Specimens after Failure

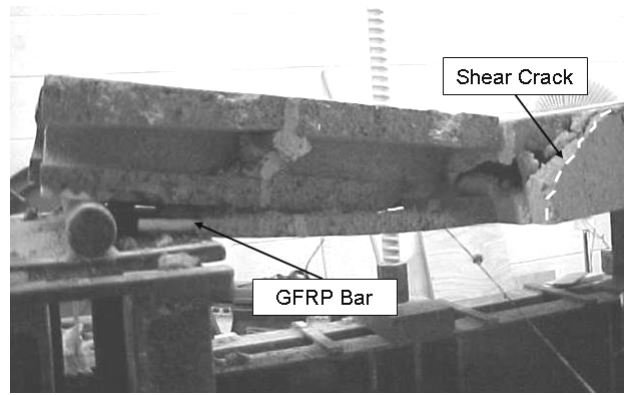
Walls 2 and 3 failed due to shear (see Figure 3b). Similarly to Wall 1, cracking started in the mortar joints at the maximum bending region. At the final stage, some debonding of the FRP bars was observed, a consequence of differential displacement in the shear plane. In general, initial cracking was delayed and the crack widths were thinner as the amount of FRP reinforcement increased.

(b) Shear Failure (Wall 3)

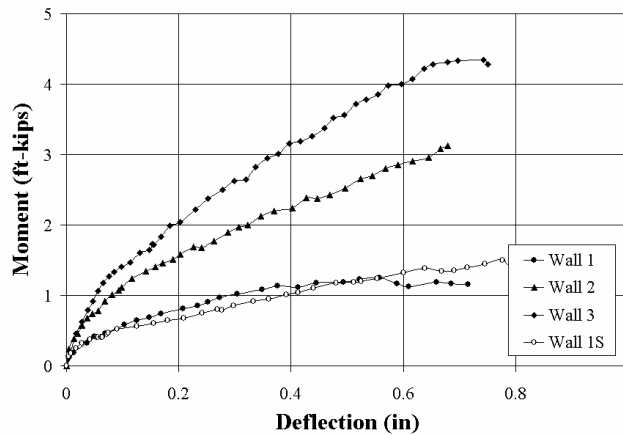
Figure 4. Moment vs. Deflection Curves

Figure 4 illustrates the moment vs. deflection curves for the four test specimens. The flexural strength and stiffness of the FRP strengthened walls increased as the amount of reinforcement increased. Following the Masonry Standards Joint Committee (MSJC, 1999), the nominal strength of an URM member can be computed as 0.33 ft-kips. Thus, increments of 4, 10 and 14 times the original masonry capacity were achieved for Walls 1, 2 and 3, respectively. These large increments should be taken as reference, since they depend on the masonry variability (i.e. labor and materials) and boundary conditions (i.e. if the wall can be analyzed as simply supported). Wall 1S, which failed by debonding of the FRP laminate, exhibited a similar behavior to that observed in Wall 1.

Figure 4 allows to observe that the flexural stiffness is a function of the amount of FRP, the levels of pseudo-ductility appear to be similar. Wall 2 exhibited a lower ultimate load than Wall 3, which can be attributed to the nature of the shear failure. In the case of Wall 2, sliding shear in the plane of a mortar joint was observed, whereas in Wall 3, the shear crack was diagonally oriented. The GFRP strain in Wall 1 at failure was 0.8%, which represented about 43% of the ultimate strain of a #3 GFRP bar. In Walls 2 and 3, the strain readings indicated 0.8% and 1.0%, respectively.

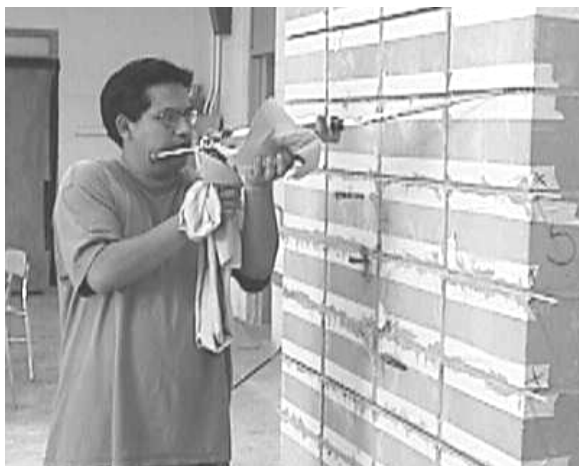
(a) Application of Embedding Paste

Figure 5. Strengthening by Structural Repointing

In FRP structural repointing, the aesthetics of masonry can be preserved. In this technique, the diameter size of the FRP bars is limited by the thickness of the mortar bed joint, which usually is not larger than $\frac{3}{8}$ inches. The strengthening procedure consists of: (1) cutting out part of the mortar using a grinder, (2) filling the bed joints with a epoxy-based or cementitious-based paste (see Figure 5a), (3) embedding the bars in the joint (see Figure 5b), and (4) retooling.

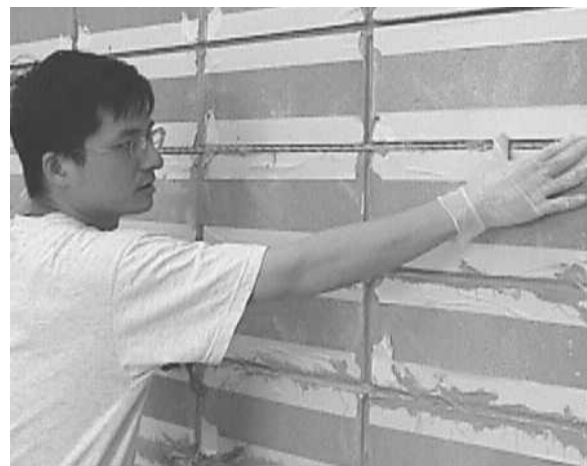
(b) Installation of GFRP Bars

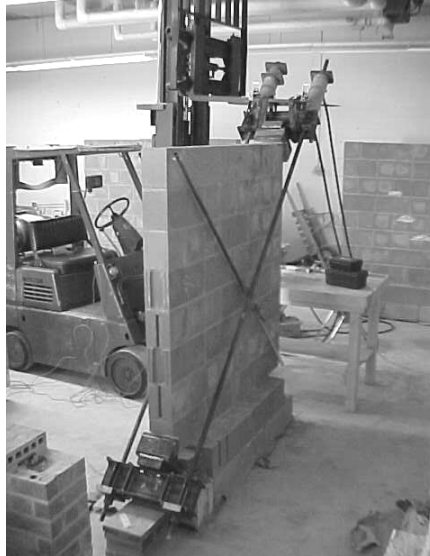
Figure 6. Test Setup

The specimens, tested in a close loop fashion, were loaded along one diagonal. LVDTs were placed along the wall diagonal to monitor deformations. The force was applied to the wall by steel shoes placed at the top corner, and transmitted to similar shoes at the bottom corner through high-strength steel bars. Figure 6 illustrates the test setup.

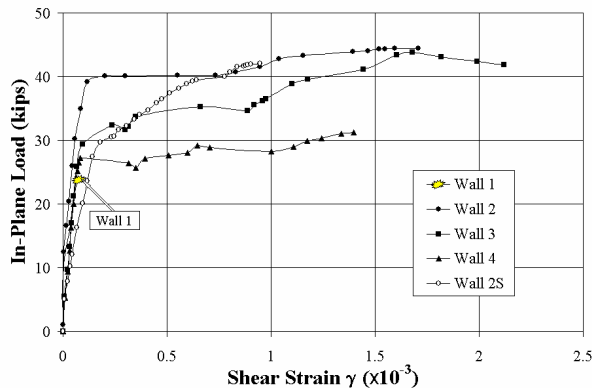
Figure 8. In-Plane Load vs. Shear Strain

Figure 8 illustrates the in-plane load vs. shear strain curves for the test walls. It can be observed that Wall 3 exhibited the largest pseudo-ductility value, which can be attributed to reinforcement staggering on the two wall sides. The pseudo-ductility values estimated for Wall 4 was the smallest of all the strengthened walls. As it was mentioned before, this is caused by the occurrence of sliding shear. It is observed that the walls strengthened with FRP bars (Wall 2) and FRP laminates (Wall 2S) had similar shear capacity; however, the pseudo-ductility was less in the Wall 2S, which was caused by the occurrence of the sliding shear failure.

Specimen	In-Plane Load	γ_u ($\times 10^{-3}$)	γ_y ($\times 10^{-3}$)	μ
Wall 1	24.3 kips	0.09	0.09	1.0
Wall 2	44.4 kips	1.75	0.13	13.5
Wall 3	43.8 kips	1.82	0.09	20.2
Wall 4	31.3 kips	1.38	0.11	12.5
Wall 2S	42.1 kips	0.95	0.12	7.9

where ϵ_0 and ϵ_{90} are the normal strains associated to the wall diagonals. The γ values at ultimate and yielding are presented in Figure 8.

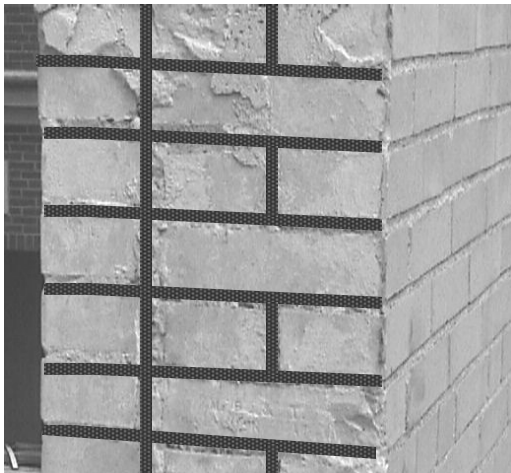
Three multiwythe steel reinforced masonry walls built using clay units were tested (see Figure 9a). These walls were parapets of a decommissioned building in St. Louis, Missouri. Their dimensions were 5x5 ft. The overall thickness of the walls was 12.5 in. The multiwythe walls were built with cored bricks having the following dimensions, 3.75 in. wide, 2.25 in. high and 8 in. long, with three cores of 1.5 in. diameter. The compressive strength in masonry was determined to be 1400 psi. Tests performed on the steel reinforcement showed that the yielding strength was 50 ksi.

(a) Vertical Cross Section

Figure 9. Details of Masonry Walls

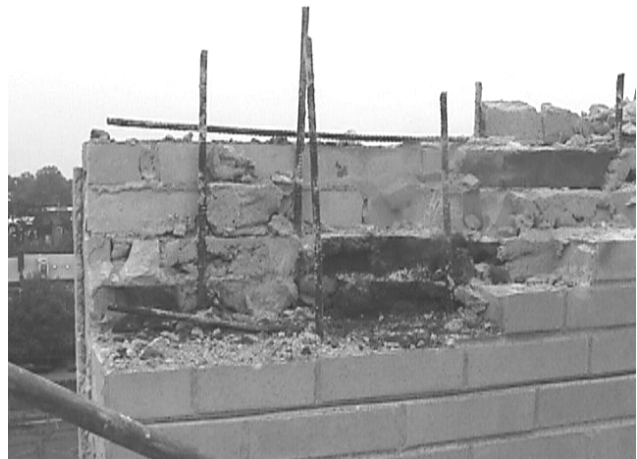
According to the original drawings, the walls were horizontally and vertically reinforced with #3 steel bars, spaced at 6 in. on center, and placed in the joints between wythes. However, after inspection, it was observed that several steel bars were missing or irregularly placed as can be observed in Figure 9b. This fact made difficult to assess the actual capacity of the members.

(b) Irregular Steel Distribution

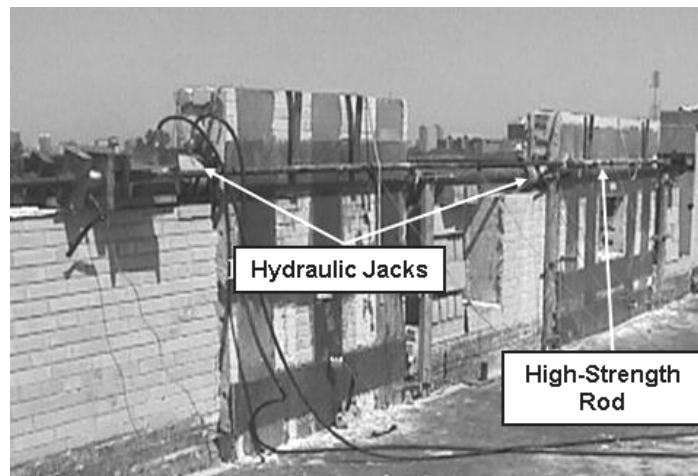
Figure 11. In-Plane Test Setup

The masonry walls were in-plane loaded as cantilever walls, with free rotation and movement at the top and fixed at the base. The loads were generated by the alternate use of two hydraulic jacks. Thus, two walls could be tested in series at the same time (See Figure 11). LVDTs were placed at the top of the walls to register displacements. Details of the strengthening schemes and test procedure are presented elsewhere (Tumialan, 2001).

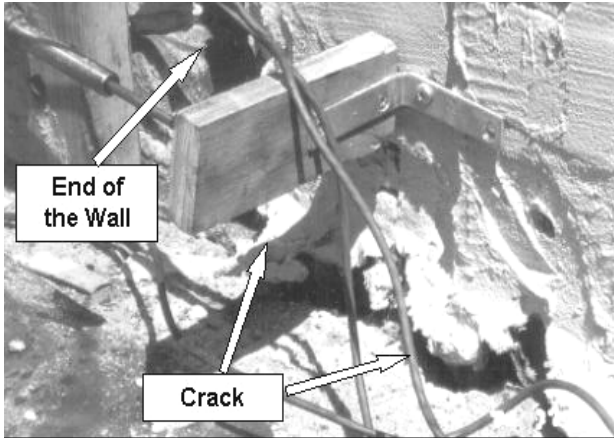
Wall 1 was used as control specimen to assess the flexural capacity from in-plane loading prior to strengthening. A maximum force of 9.7 kips occurred for a displacement of about 0.03 in. The wall lost carrying capacity due to the crack growth caused by rocking. The crack length when the test was terminated covered approximately two-thirds of the base length (see Figure 12a). Base sliding was not observed at this final stage. Compared to calculations, the flexural capacity in Wall 1 was significantly low. This was attributed to the deficient anchorage of the existing vertical steel reinforcement, which pulled out from the wall. This reinforcement was placed in the space between the wythes, which was filled with the same mortar used to lay the masonry units.

(a) Crack in Wall 1

Figure 12. Flexural Cracks at the Bottom of Walls

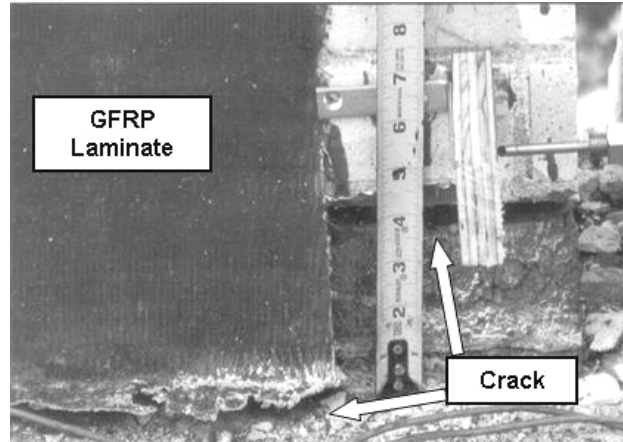
Similarly to Wall 1, a flexural crack was observed at the base of the Wall 2 for a load of 3.5 kips. Flexural failure was observed at about 12 kips for a displacement of 0.04 in. This slight increment may be attributed to the bridging of some secondary cracks near the bottom by the FRP laminates. Similarly

to Wall 1, the primary flexural crack causing the failure was observed at the bottom of the wall (see Figure 12b).

(b) Crack in Wall 2

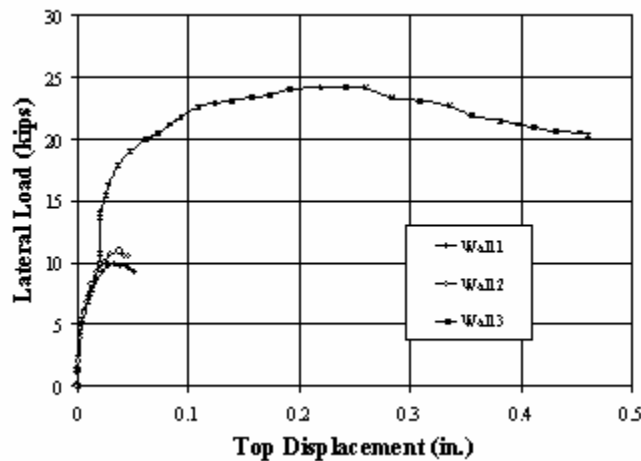
Figure 13. Lateral Load vs. Top Displacement

An envelope of the load vs. top wall displacement curves is illustrated in **Figure 13**. By comparing Wall 3 to Wall 2, the increment in capacity was over 100%. Since the steel reinforcement was pulled out, the concept of ductility defined as the ratio between the deflection at the ultimate state of failure and the deflection at the yielding of steel can not be applied. In Wall 3, due to the contribution of the anchors, a notable increase in pseudo-ductility was attained.
